Leokwe Rest Camp, Mapungubwe National Park – Access for Guests with Mobility Challenges

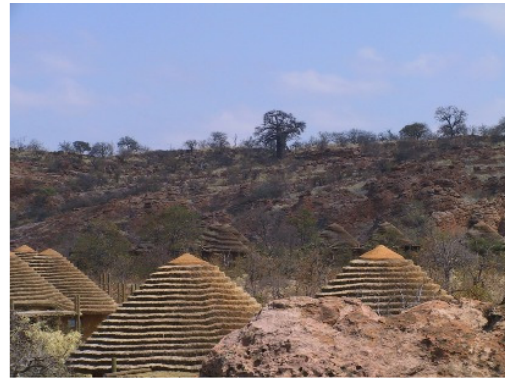
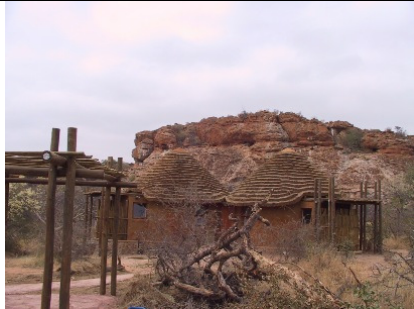
Leokwe is the largest rest camp in Mapungubwe National Park. It is a wonderful setting, located in a sheltered clearing surrounded by sandstone outcrops and baobab trees. There are 18 units, 2 of which are accessible to guests with mobility challenges, with ramped access and converted ablutions. There is also a central communal area with a plunge pool, a viewing deck, a kitchen and boma area for catering for groups larger than the individual units. This central facility does have an accessible toilet, but the rest of the facility, apart from the deck above the pool, is not accessible to a person in a wheelchair because of steps to different levels.

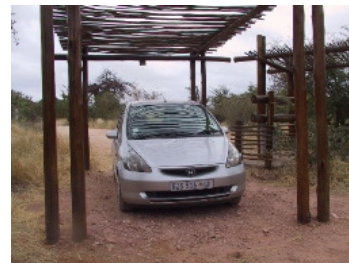
The parking outside the 2 accessible units is of ample space on either side of the car doors, so exiting and entering a vehicle is not a problem as there is open space on either side of the vehicle. However the ground surface, while firm in places is soft powdery sand in places and this compromises the ability for a wheelchair user to move around, particularly when carrying luggage.
